Subject: Smoky Canyon Mine Remedial Investigation/Feasibility Study
Final Dinwoody Material Source Investigation Report

To: Jeff Hamilton, Environmental Engineering Manager; Grant Williams, Senior Mine Engineer
From: Katie Wilkes, Geologist
Cc: Neil Musilek, Engineering Manager; Casey McCaslin, Survey
Date: February 21, 2019
Re: **Final RI FS Dinwoody Borrow Test Excavations**

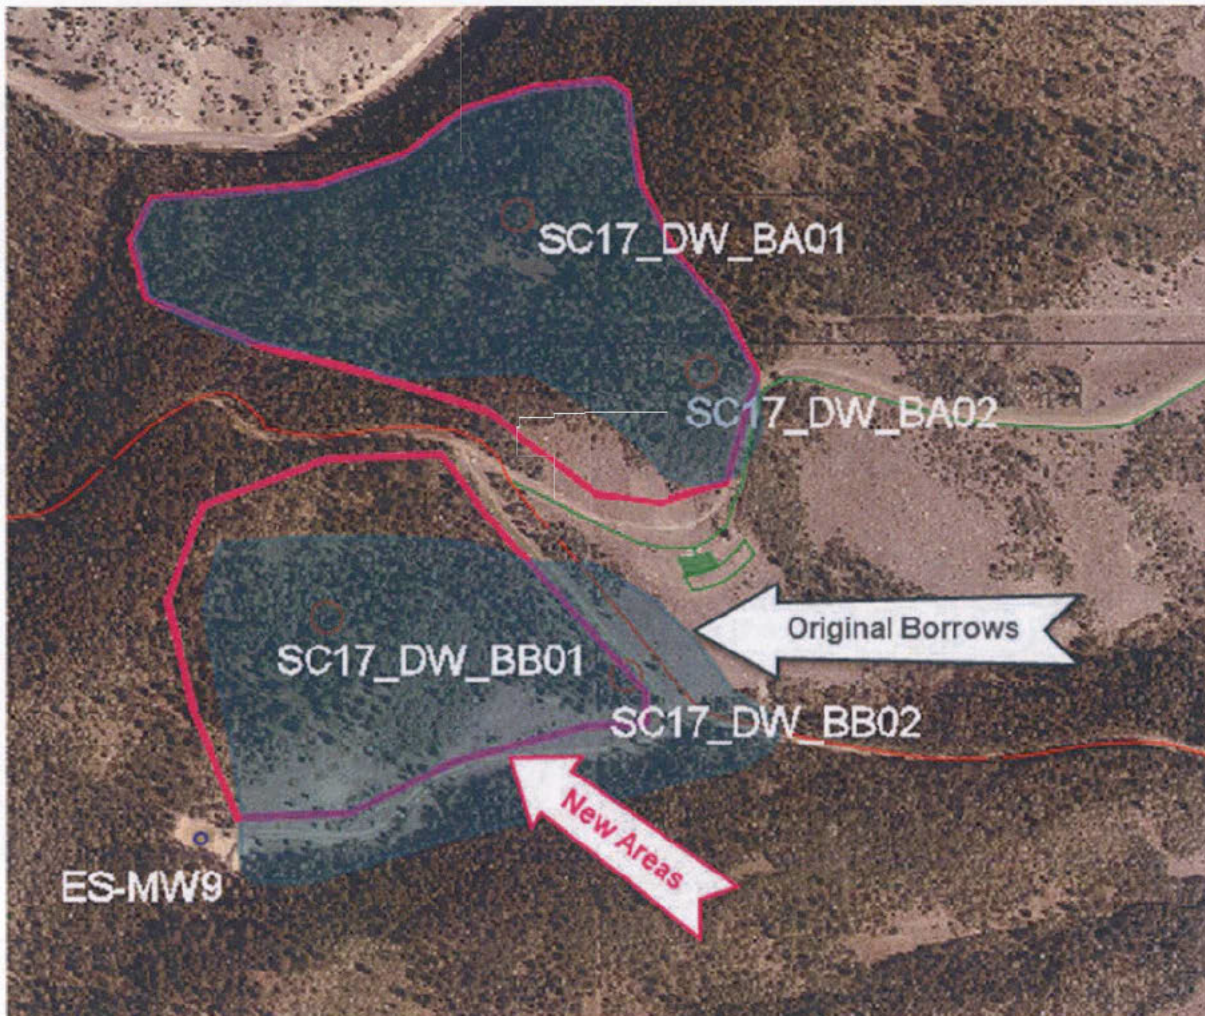
Figure 2 – B-Panel Borrow

Documentation for each excavation site and any other field observations are in the trench logs attachment. B-Panel borrow contained excellent clay rich material overall. All excavations in this area were extended to the maximum reach of the equipment. Site DW_BB02 had some less desirable gravelly zones near the surface and has been adjusted to the edge of the borrow area. **Figure 2** indicates the areas of the original B-Panel borrow designs and the new adaptations following examinations from this field program. Selected images for each site are included in this report, additional photo documentation is available within the attachments.

Volumes in this area were updated anticipating removal of 4 feet of topsoil with an overall 30 foot deep excavation below topography. Good material likely exists deeper as the excavations terminated in with good clay material at the bottom.

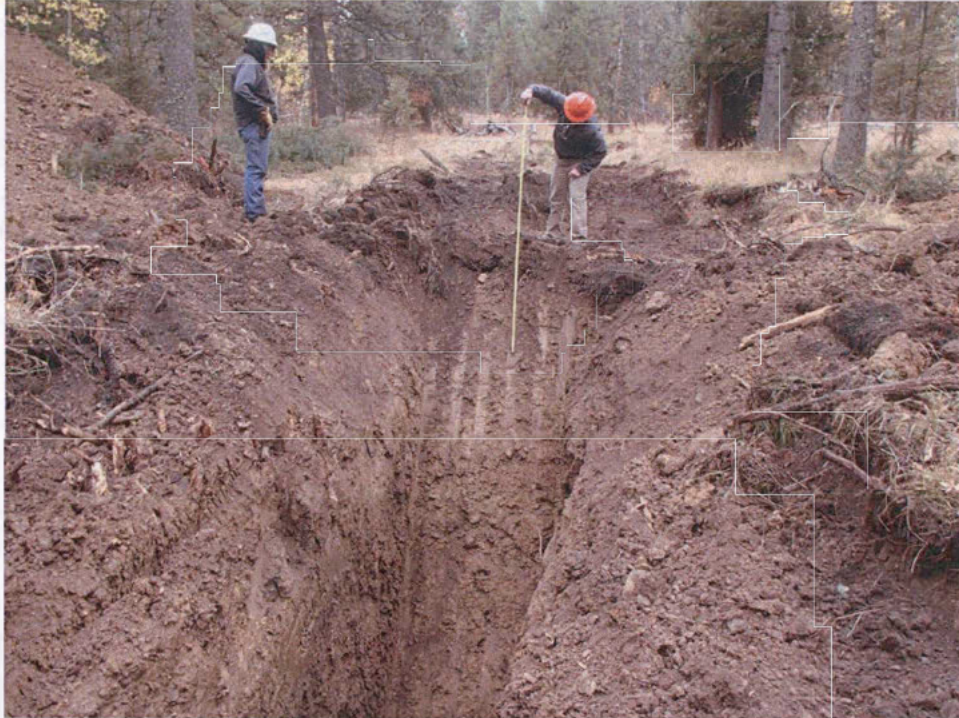
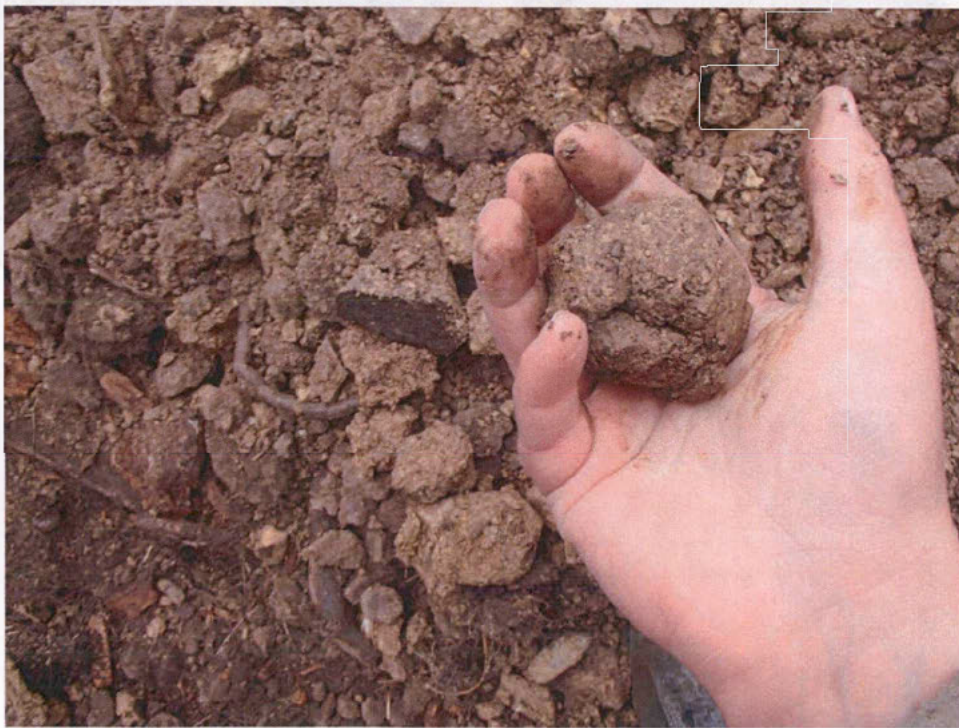
DW_BA01

0-4 Soil (OL) organic silt/clay

4-25+TD light brownish orange-grey DW (CH) soft to stiff clay, moldable – good

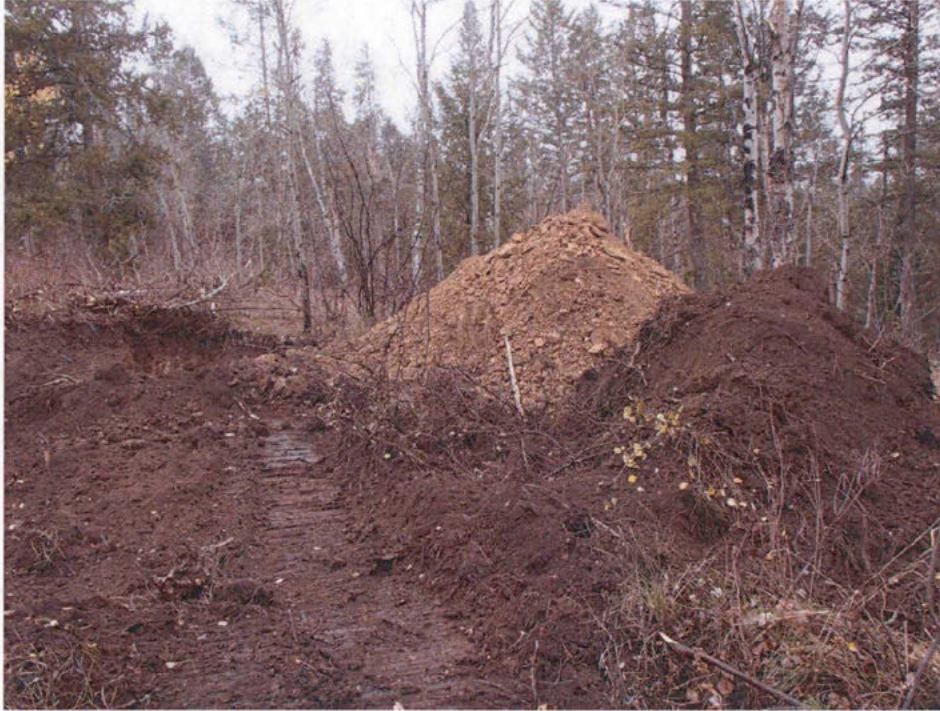
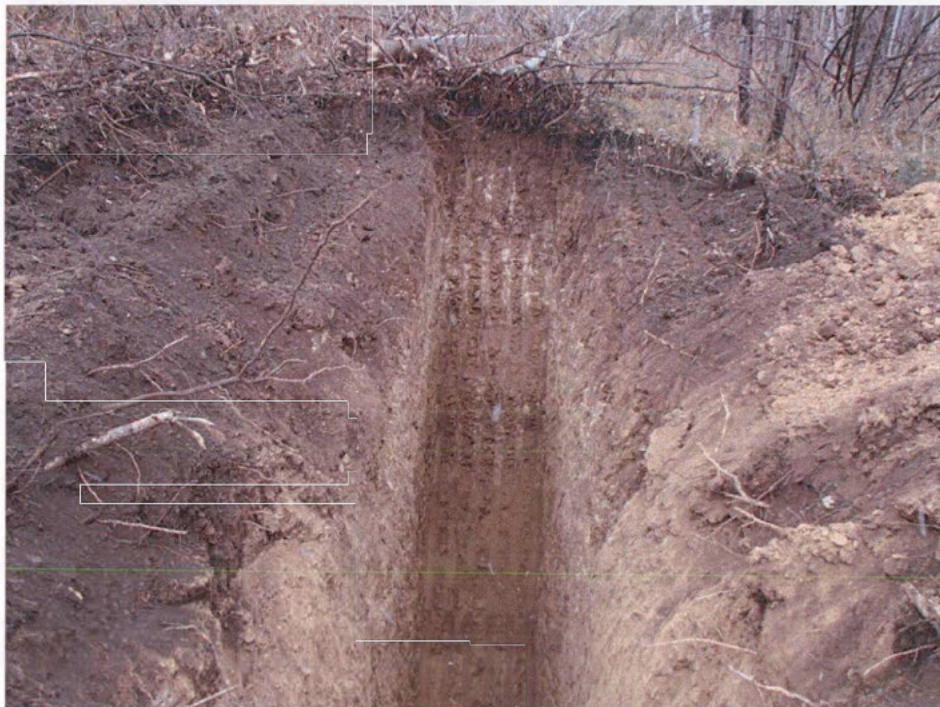
DW_ BA02

0-4 Soil (OL) organic silt/clay

4-25+TD yellowish orange-tan DW (CH) very stiff to hard clay, platy – good

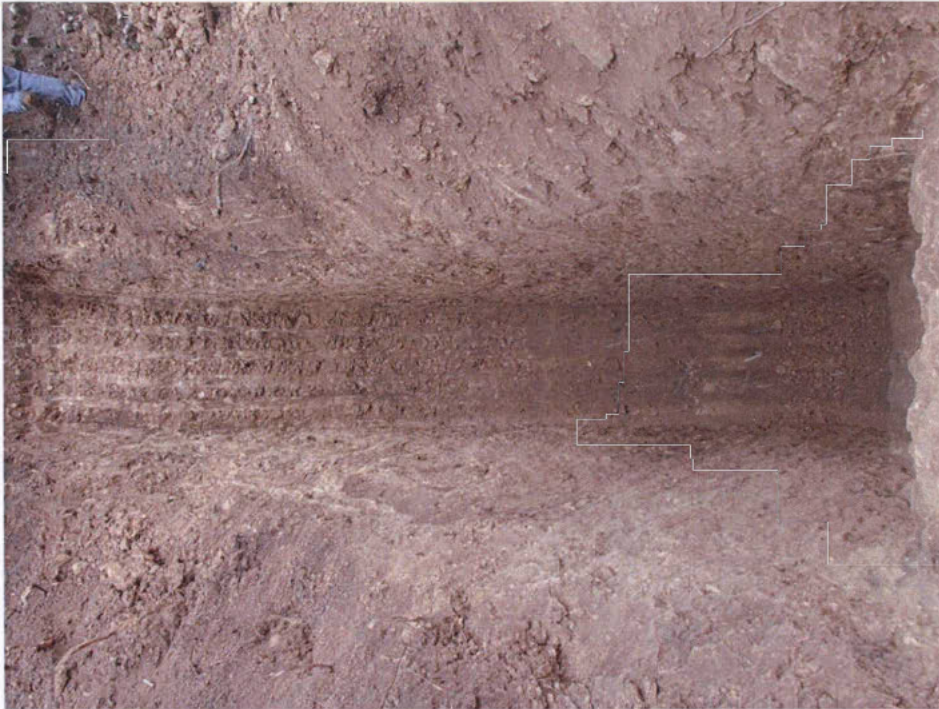
DW_BB01

0-3 Soil (OL) organic silt/clay

3-15 yellowish-orange DW (CH) Stiff Clay – good

15-25+TD olive-grey DW (CH) Stiff/Very Stiff to Hard Clay – good

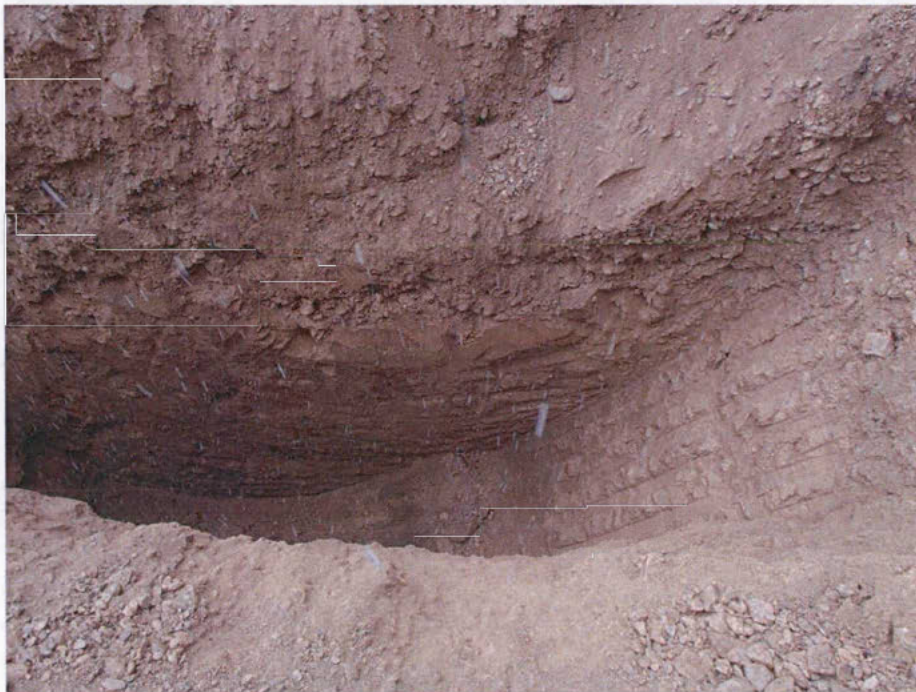
DW_BB02

0-5 Soil (GC) clayey gravels/ sand-clay mixture

5-10 well rounded (GC) mixture cobbles –gravel/clay – poor

10-25+TD light brown DW (CH) Stiff to Hard clay – good

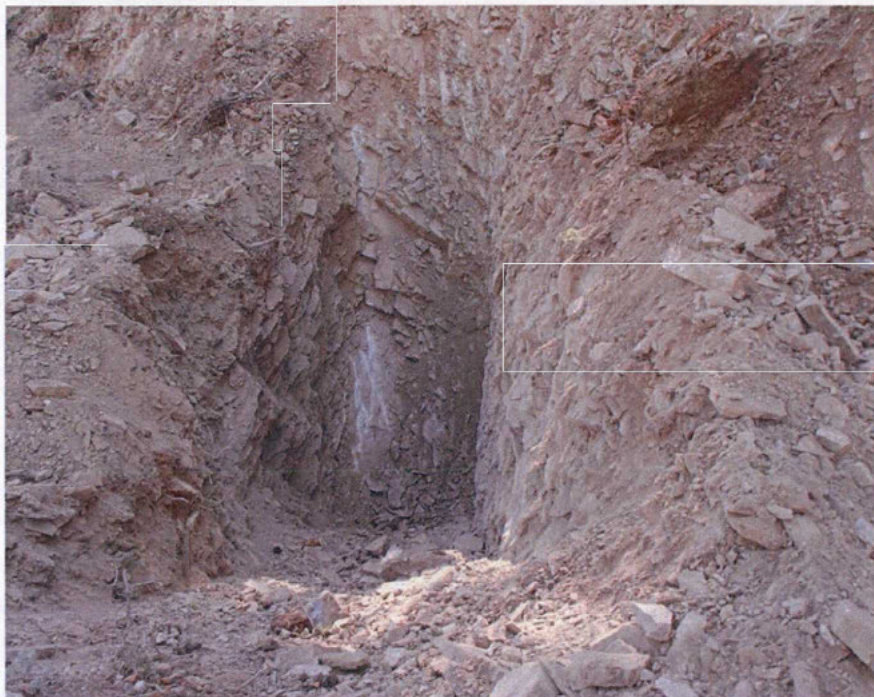
DW_ DA01

0-2 Soil (GC) light brown angular clayey gravels, fine sand-clay mixture

2-22+/-TD dark brown-red staining/dark grey rocky DW shale/limestone boulders/cobbles – bad

Refusal @ TD (broken ripper tooth)

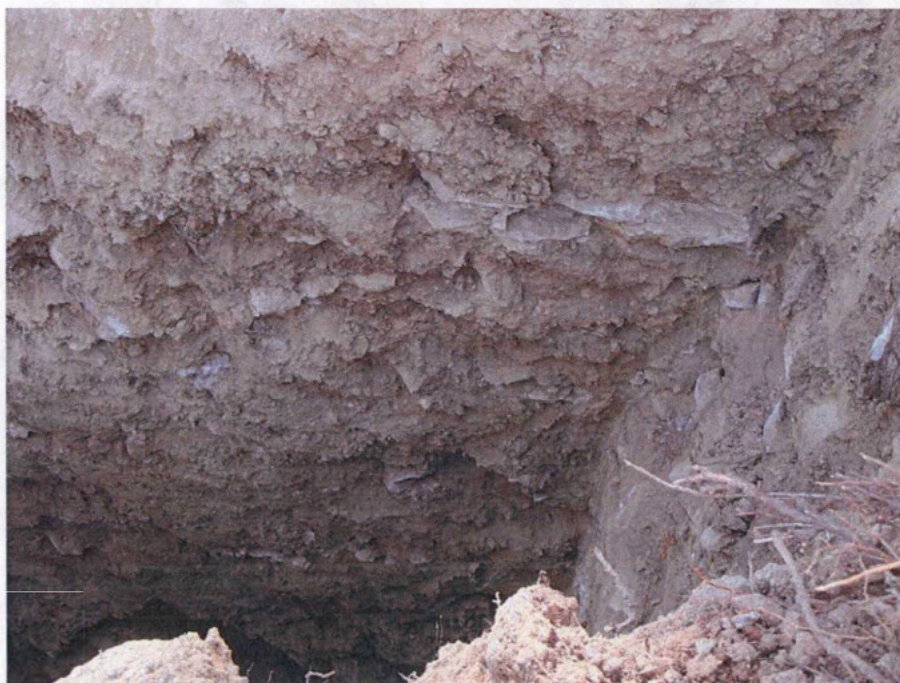
DW_ DA02

0-3 Soil (GC) light brown angular clayey gravels, fine sand-clay mixture

3-15 light brown/light grey DW rocks, clayey matrix ~40% gravel, ~5+% cobbles – poor

Grades into boulder rocks at varying depth

15-20 light brown/light grey DW shale/limestone rock –bad

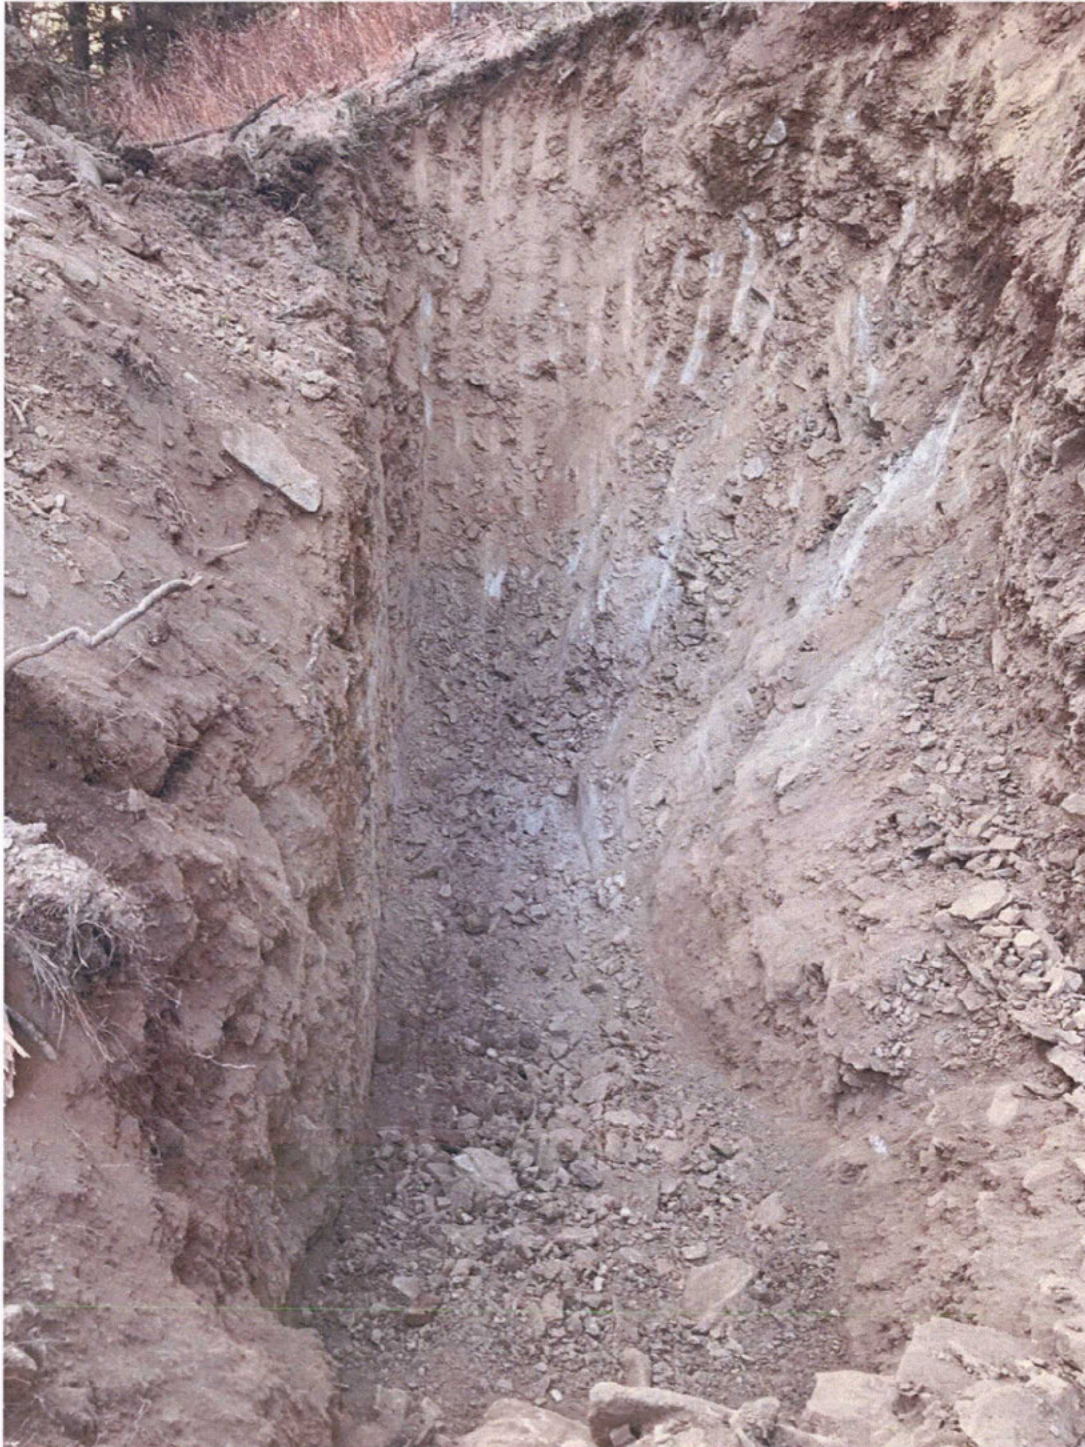
DW_DA03

0-1.5 Soil (ML) light brown fine silty-clay mixture

1.5-5 light brown/light grey (GC) DW rocks, gravel-cobble in clay-silt matrix– poor

Grades into boulder size shale/limestone rocks

5-14+TD light grey/light brown DW shale/limestone rock –bad

Refusal @ TD (broken ripper tooth)

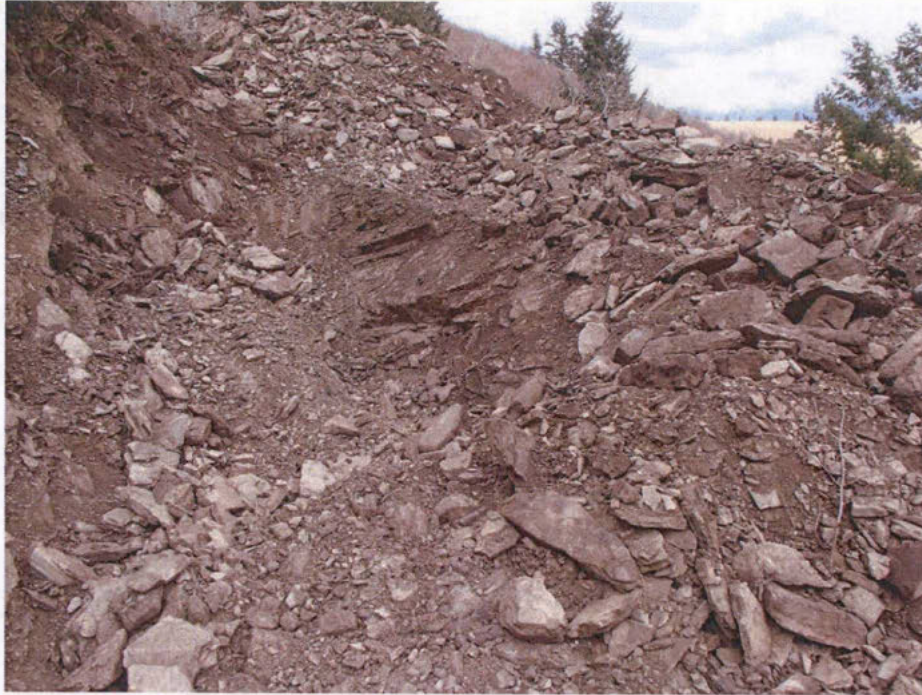
DW_DB01

0-2+ Soil (OL) dark brown fine silty-clay matrix

2-13+TD reddish brown/light grey DW shale/limestone rock – bad

10' from top of cut to pad plus 3' trench

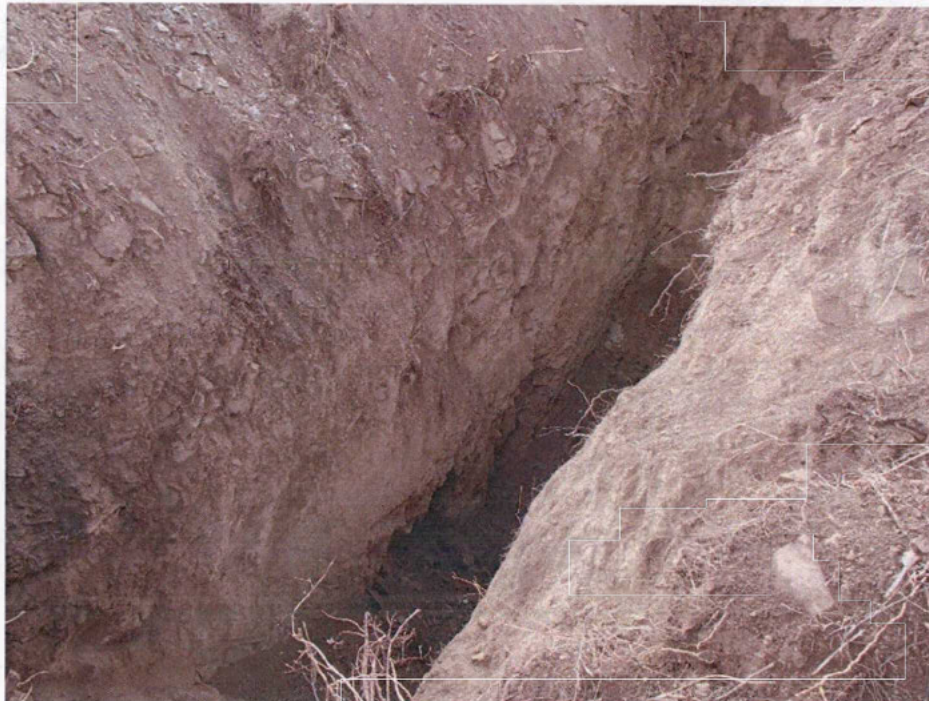
DW_DB02

0-7 Soil (GC/ML) light brown – yellowish and light grey fine silty-clay mixture with some angular gravel some plasticity –poor

Grades into boulder size shale/limestone rocks

7-15+TD light grey/light brown DW shale/limestone rock – bad

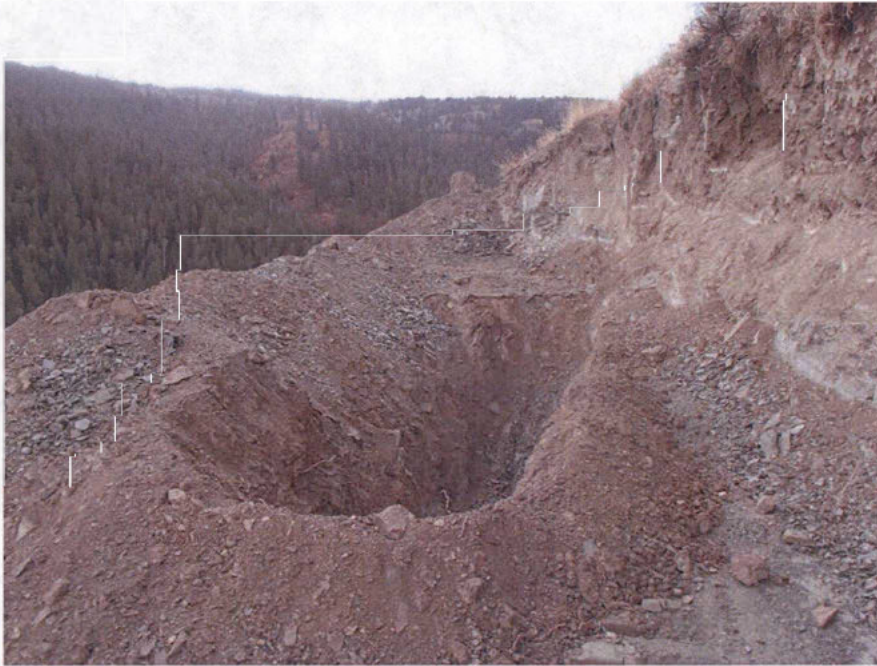
DW_DB03

0-4+ Soil bottom of roots (GC) light brown fine silty-clay matrix with gravely shale rock

4-7+TD yellowish/orange and light grey DW shale rock, interbedded seams of dark red-brown limestone rock– bad

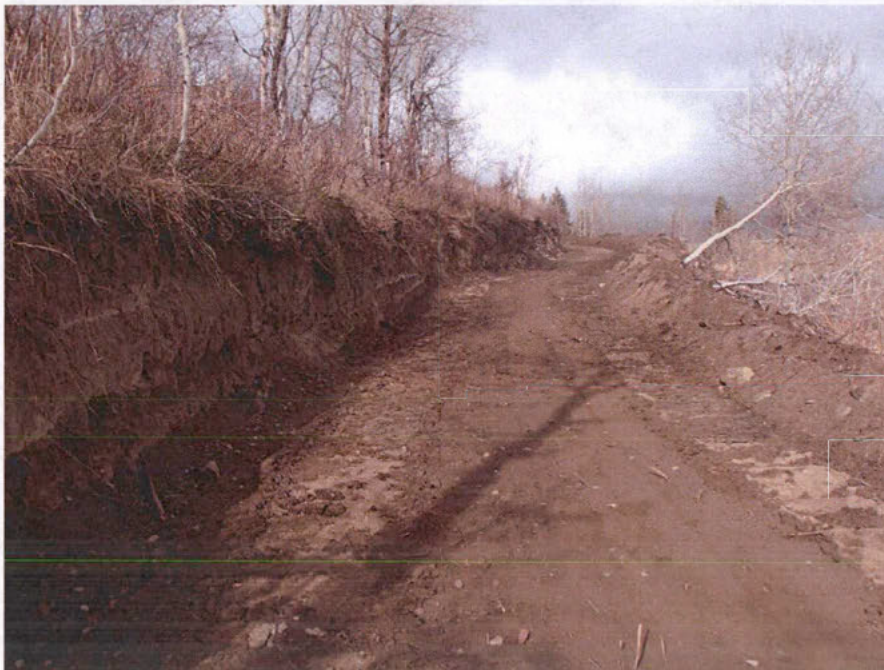
D-Panel Borrow B Road Cut

Additional note: half of the first switch back looked to have up to/ at least 5 feet of decent fine grain clayey material in the road cut. This is only present lower on the slope/switchback and full east facing slope. The south facing slope has significantly more hard silty shale with low plasticity and clay content, an apparent contact for this material type around the edge of the slope appears to be parallel with the pillar like cliff outcrop overlooking Sage Creek below the D boneyard.

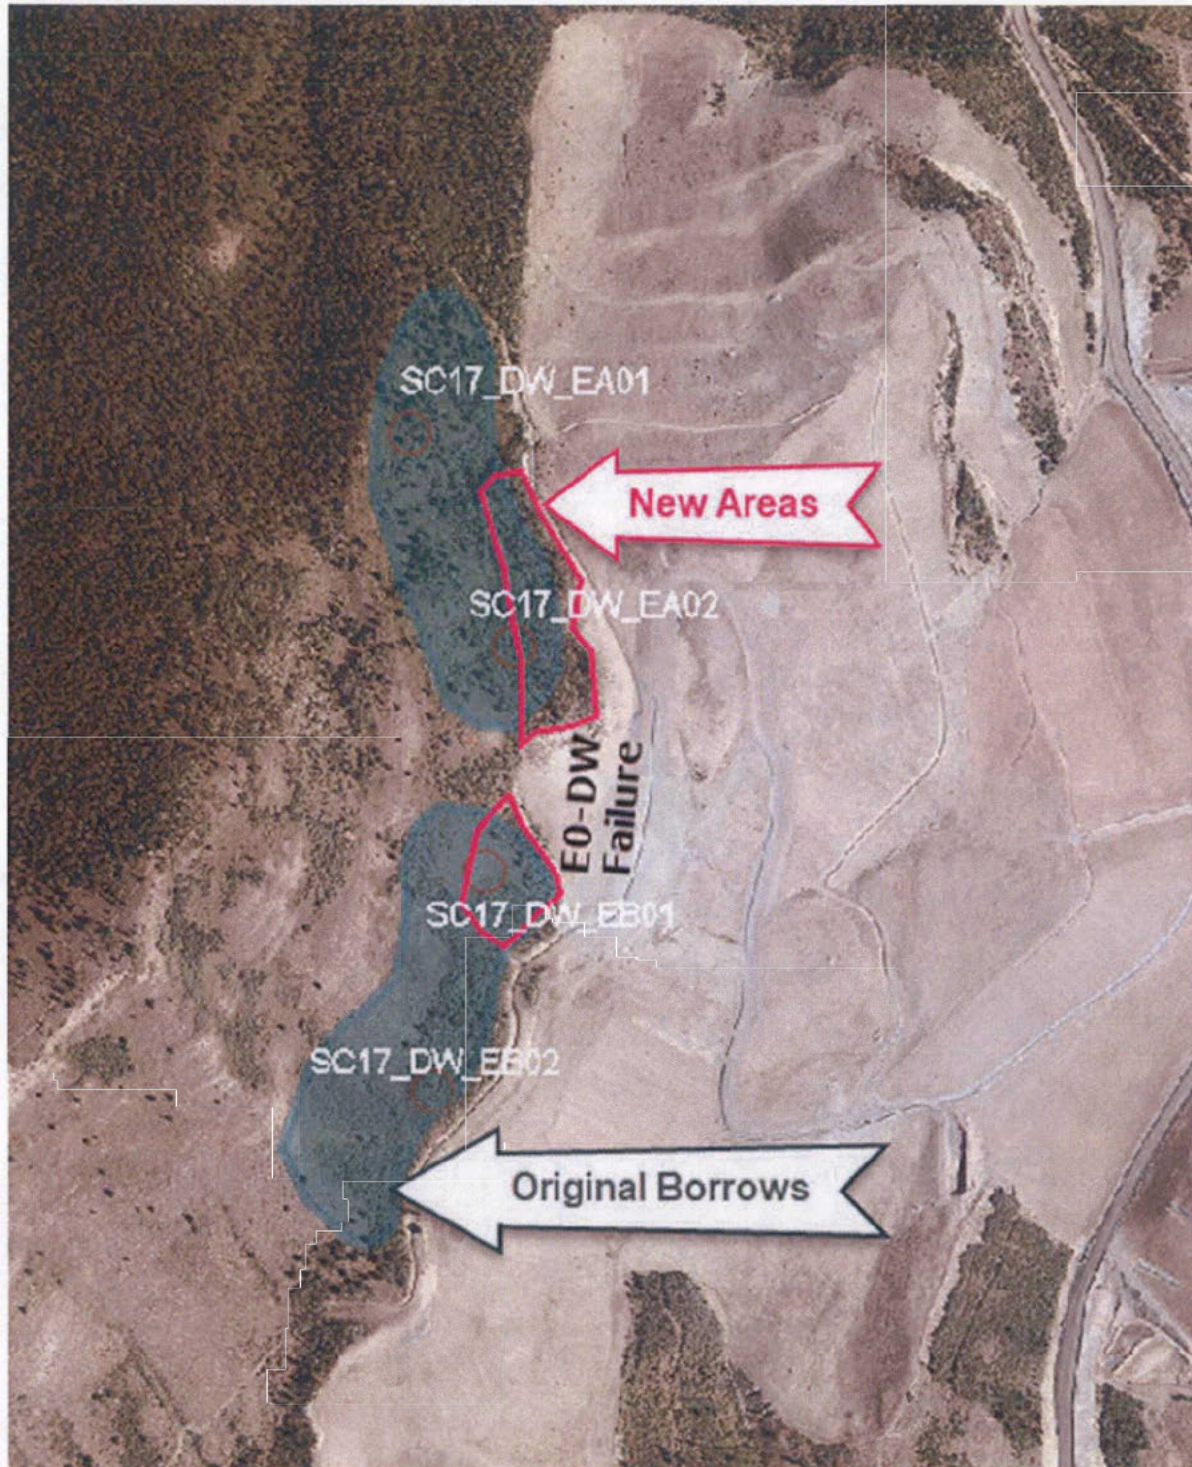
Figure 4— E-Panel Borrow

All sites were terminated at refusal of digging through rock, EA01 and EB02 were complete nearly at the surface. None of the excavation sites indicated a large quantity of good cover-

quality Dinwoody. Alternating rock and loose material in some locations saw better digging below the surface rock outcrops although none of the trenches were extended to a great depth. The upslope extent for accumulation of good usable weathered Dinwoody appears to coincide with the areas of existing borrows in both D and E panel. Additional field notes for the E-Panel borrow excavation sites are in the trench logs attachment. **Figure 4** indicates the areas of the original E-Borrow designs and the new adaptations following examinations from this field program. Selected images for each site are included in this report, additional photo documentation is available within the attachments.

Volumes in this area were updated within a much smaller areas. Calculations within this area assumed 3 feet of topsoil and 15 feet total depth for excavating material below topography. Most of this material would not be suitable for cover material.

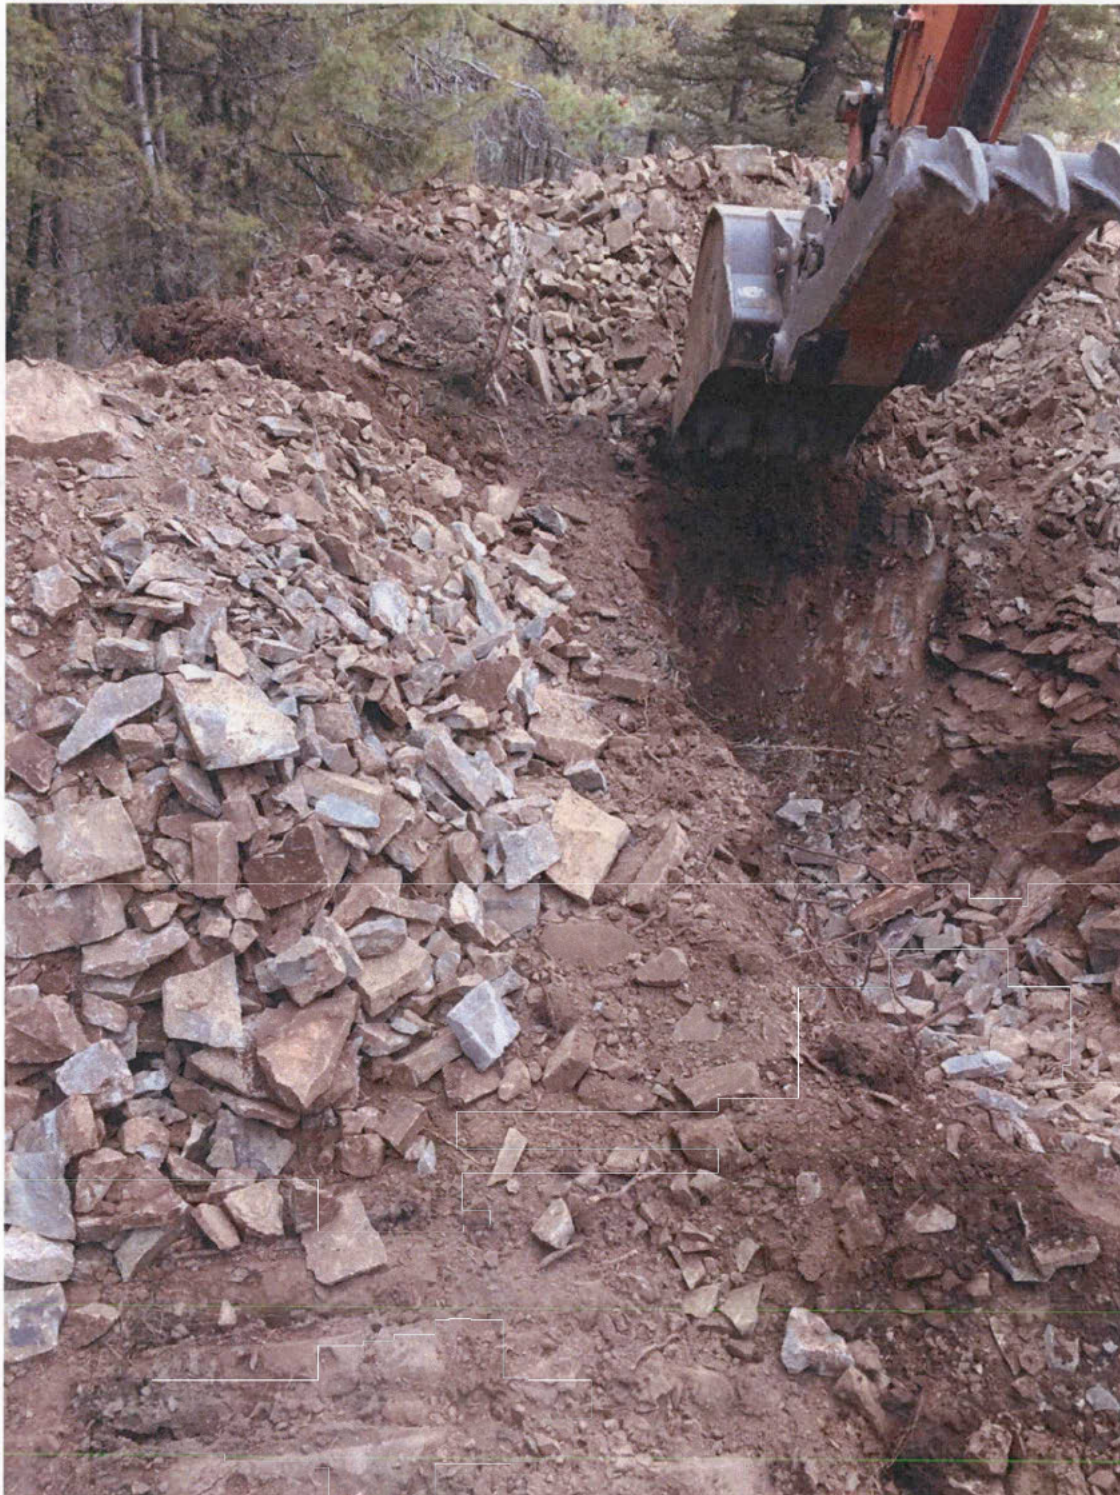
The excavator operator encountered hard rock and abandoned the dig at the surface on 10/29 and 10/30 at DW_EA01 and DW_EB02 respectively.

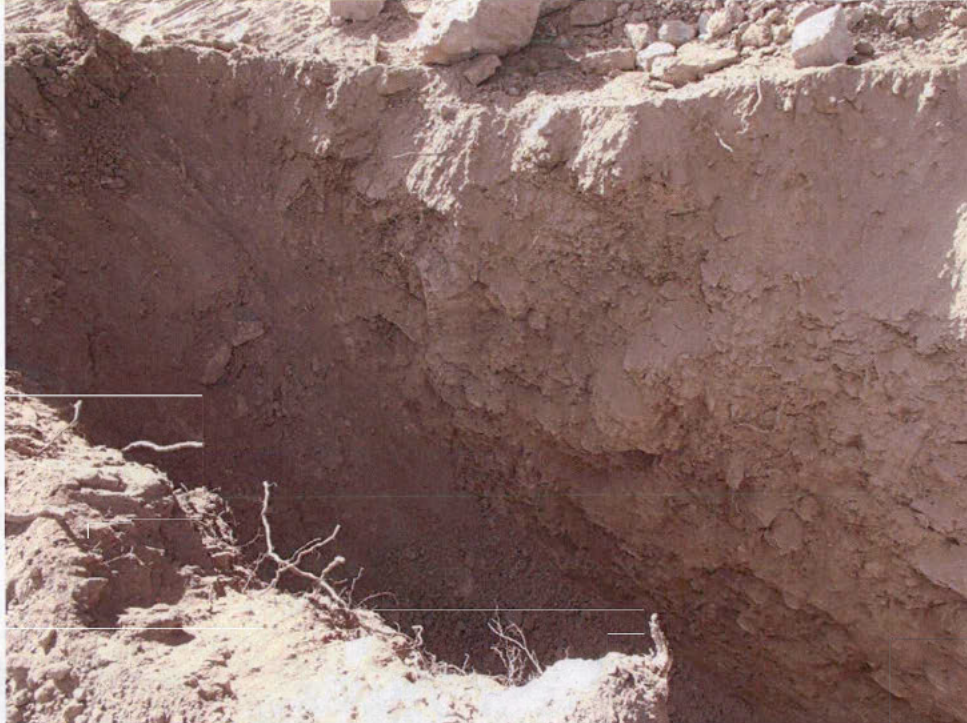
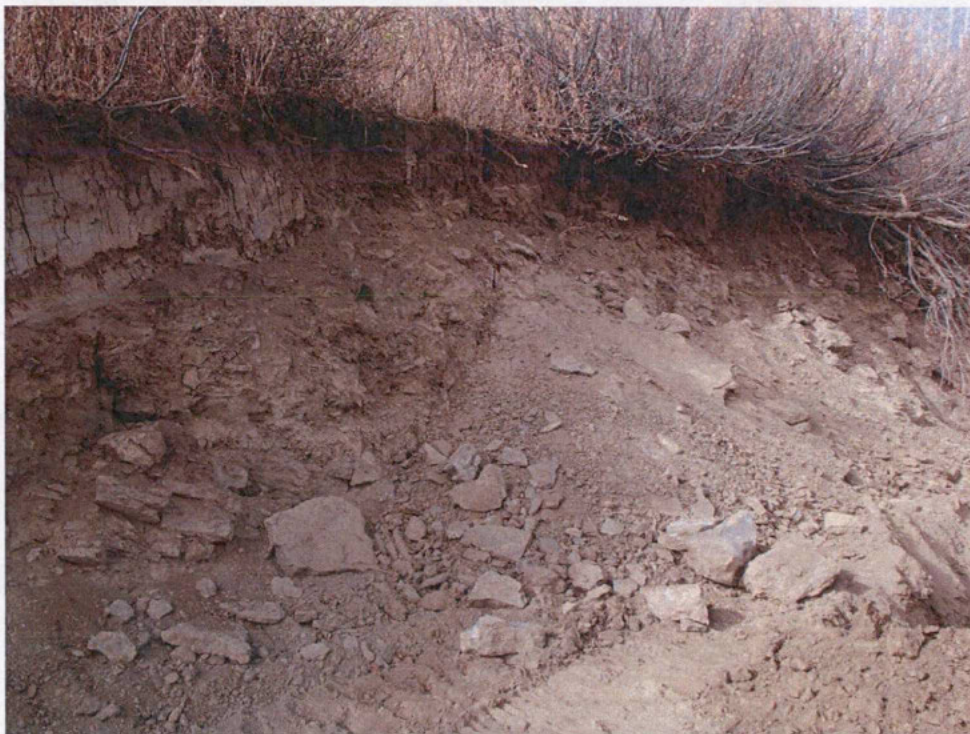
DW_EA02

0-3 Soil with plasticity and roots (OL/GC) light reddish brown fine silty-clay matrix with some gravel

3-8 light brown and grey large DW shale/limestone rocks – bad

8-16+TD (GM) light brown and grey DW shale rocks in low plasticity silty matrix, interbedded seams of dark red-brown limestone – poor

8' from top of cut to pad plus 8' trench

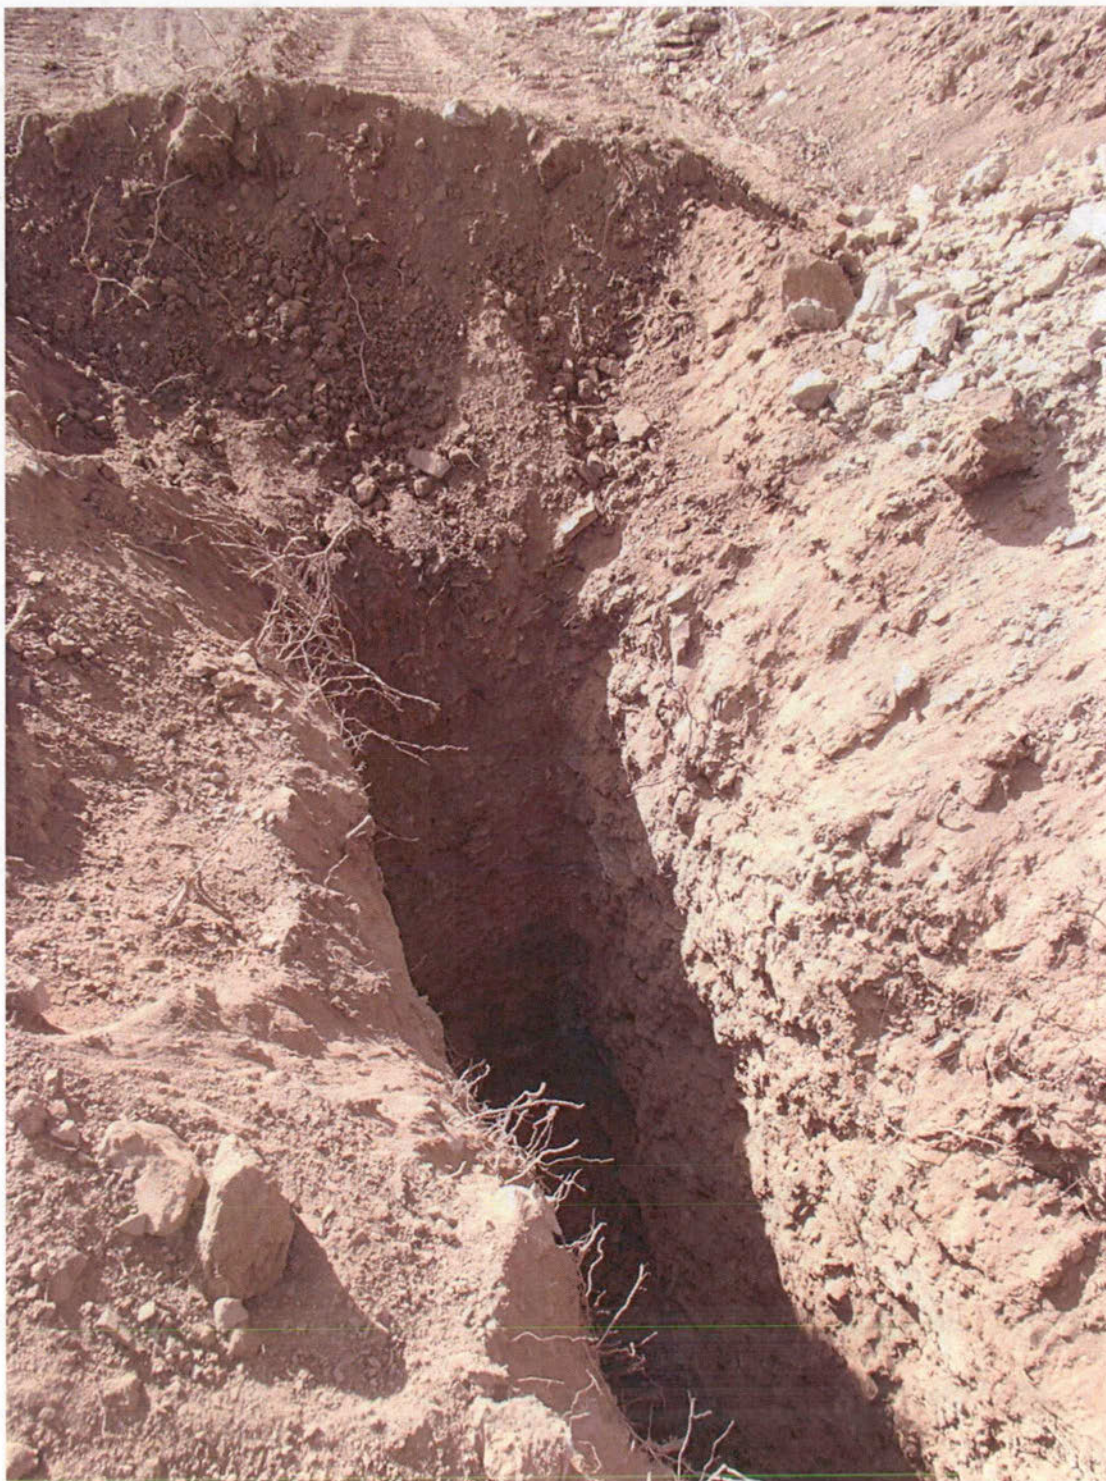
DW_EB01

0-3 Soil with roots (OL/GC) reddish brown fine silty-clay matrix with gravely shale rock

3-21+TD (GM) light reddish brown silty matrix and interbedded light grey DW shale rock– poor

9' from top of cut to pad plus 12' trench
